Mould Report

## Claim Summary

**Absolute** Mould Removal was engaged by the client to assess mould conditions at the property at . The property is a single-storey, free-standing elevated house. The inspection aimed to evaluate mould issues after property purchased .

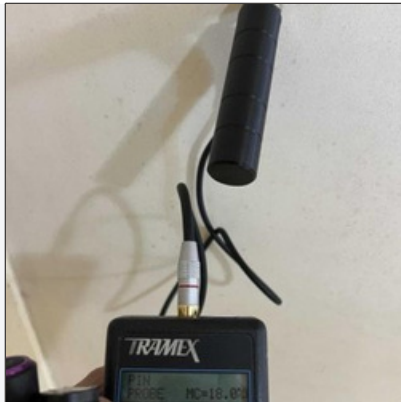
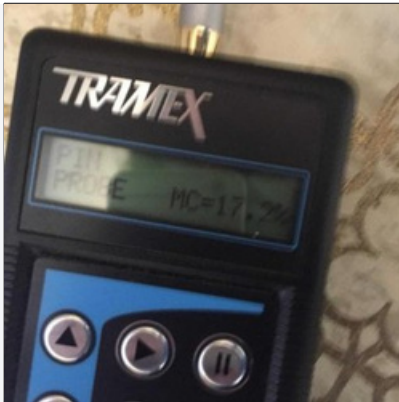
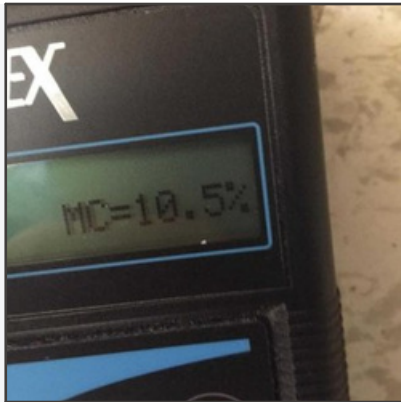
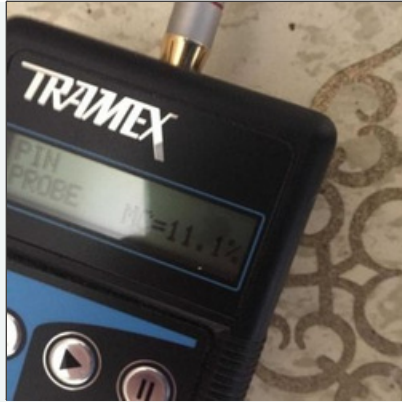
Moisture & Hygrometer Readings:  
Relative Humidity: – 63%, 35%  
Room Temperature: – 13.8°C, 05.7C  
Ceiling Moisture Reading: – 18.0%  
Wall Moisture Reading - 17.2%, 10.5%, 11.1%

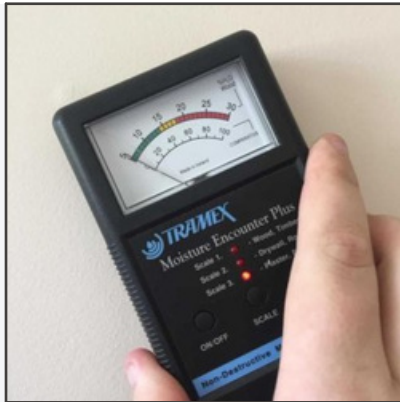
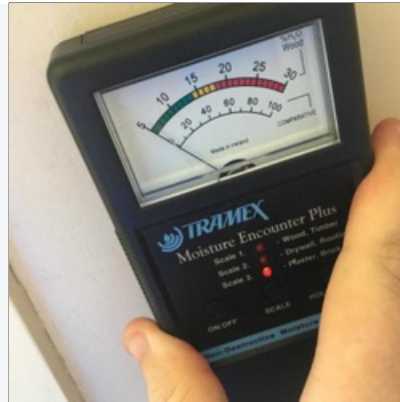
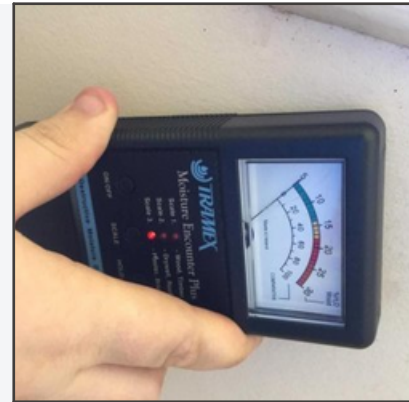
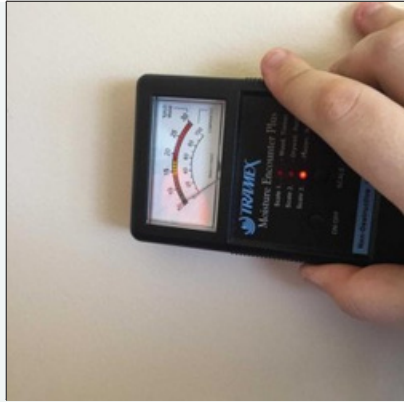
Moisture & Hygrometer Readings:  
 Relative Humidity: – 34%  
 Room Temperature: – 05.5C  
 Wall Moisture Reading: – 5.5, 5  
 Ceiling Moisture Reading - 5, 5.5

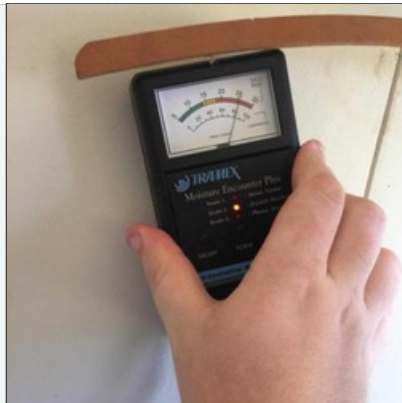
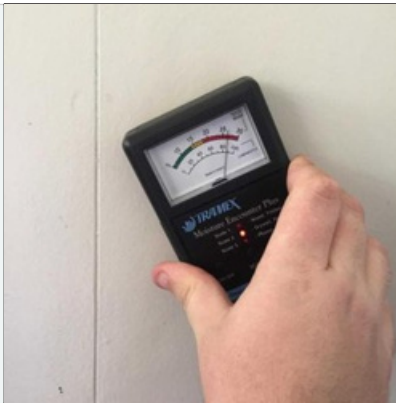
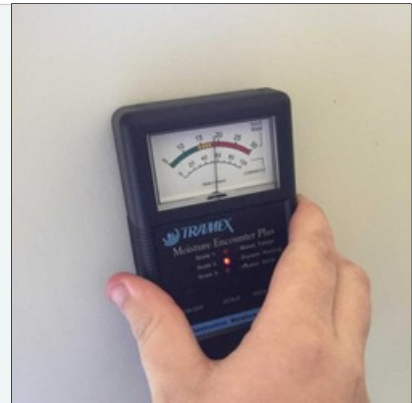
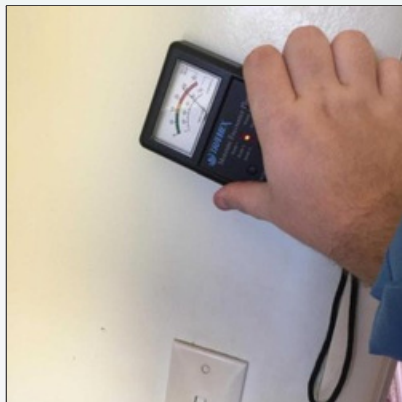
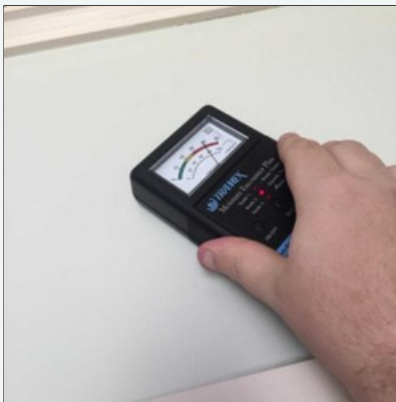
Wall Moisture Reading: – 26, 26.5, 18.5, 24.9, 25
