Mould Report

## Claim Summary

**Absolute** Mould Removal was engaged by the client to assess mould conditions at the property at . The property is a single-storey, free-standing elevated house. The inspection aimed to evaluate mould issues after property purchased .

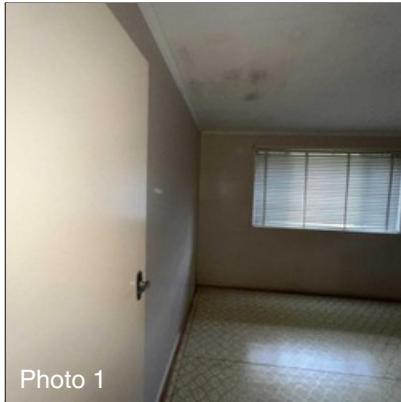
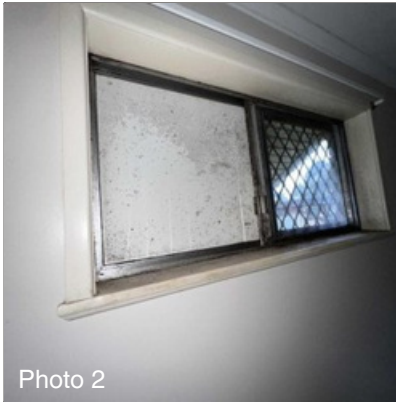
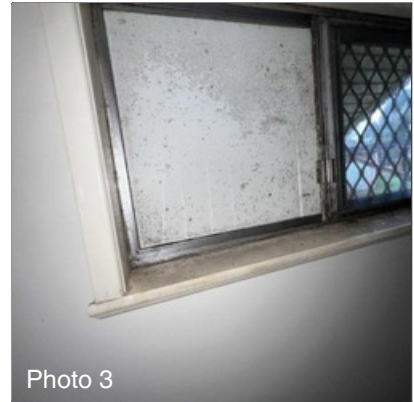
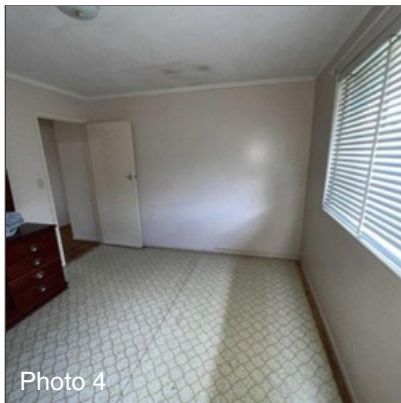
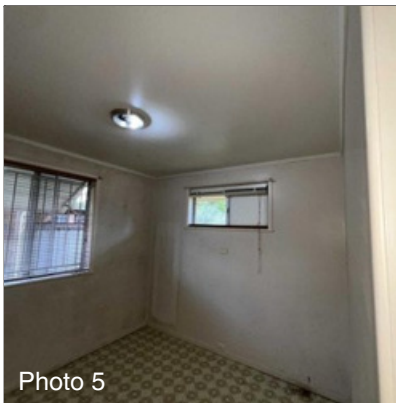
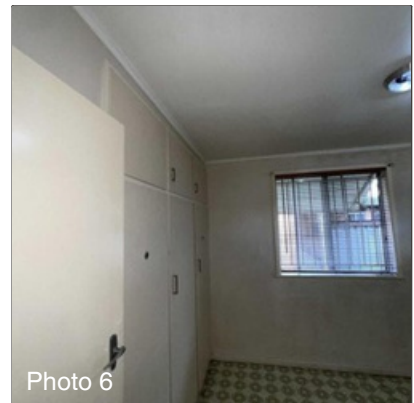
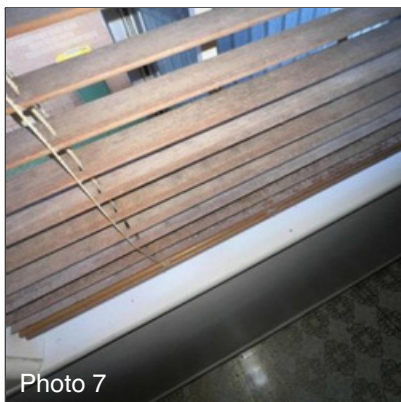
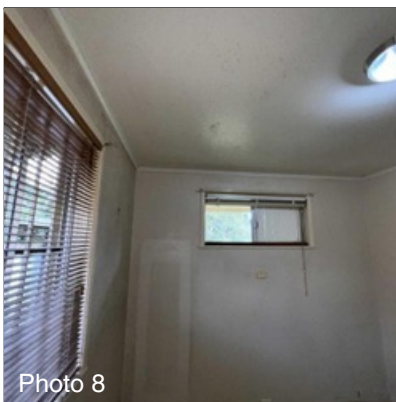
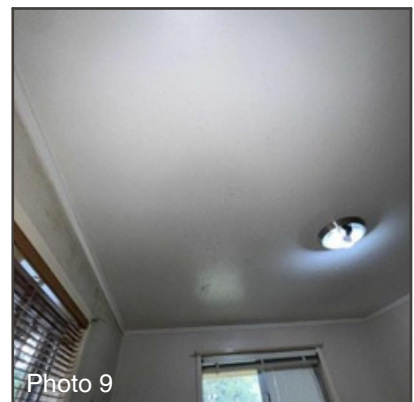
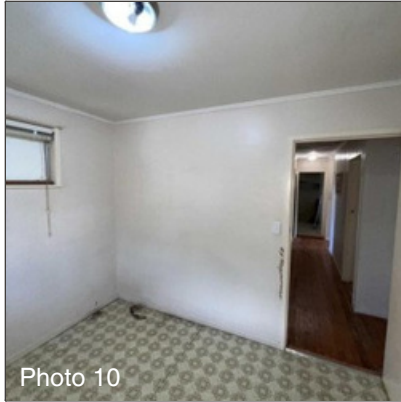
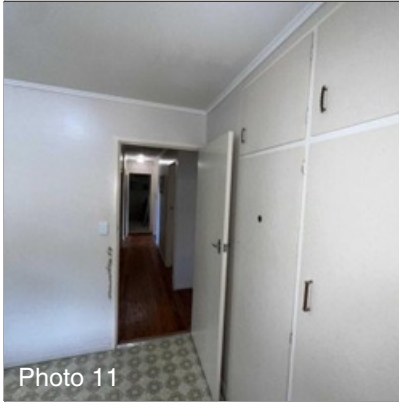
## Overview Photos: Bedroom 1

Moisture & Hygrometer Readings:  
Relative Humidity: – 63%, 35%  
Room Temperature: – 13.8°C, 05.7C  
Ceiling Moisture Reading: – 18.0%  
Wall Moisture Reading - 17.2%, 10.5%, 11.1%

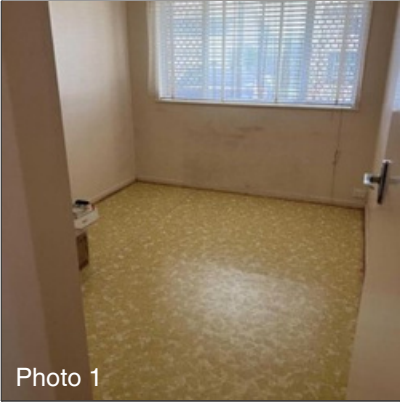
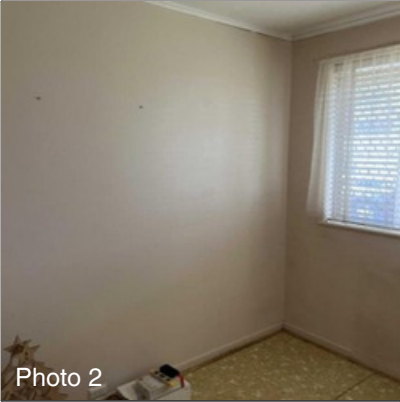
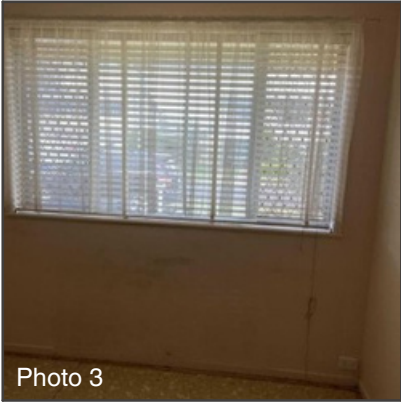
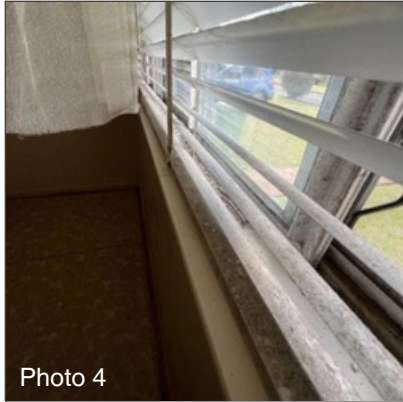
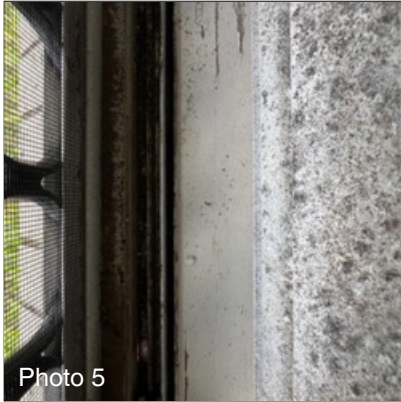
#### Overview Photos: Bedroom 3

Moisture & Hygrometer Readings:  
 Relative Humidity: – 34%  
 Room Temperature: – 05.5C  
 Wall Moisture Reading: – 5.5, 5  
 Ceiling Moisture Reading - 5, 5.5

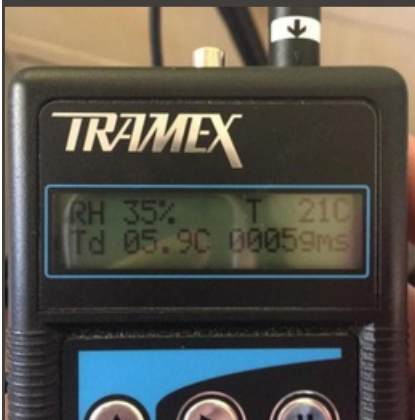
### Hygrometer

06/09/2024- Room Inspection Initial Attendance

Relative Humidity: – 35%

Wall Moisture Reading: – 26, 26.5, 18.5, 24.9, 25

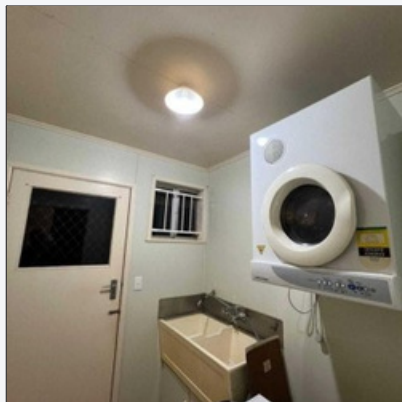
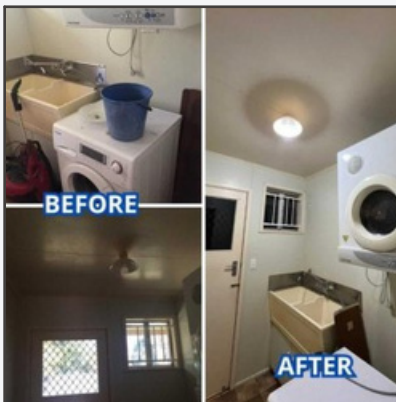
### 12.09/2024 - Room Inspection Re-Attendance

After Photos

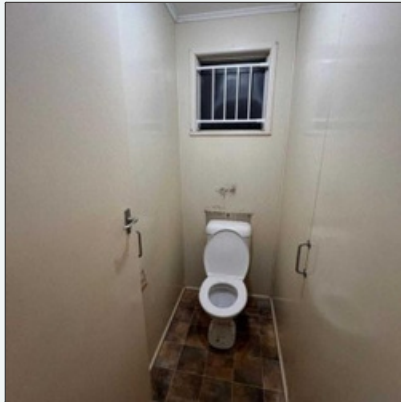
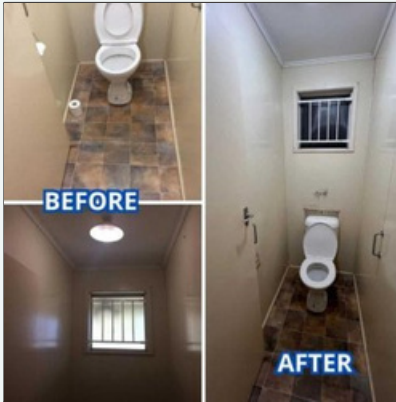
12/09/2024 - Room Inspection Re-Attendance

Room Inspection Initial  
Attendance:  
Room Size (LxWxH):  
Moisture & Hygrometer  
Readings:  
Relative Humidity: – 35%  
Room Temperature: – 05.7C

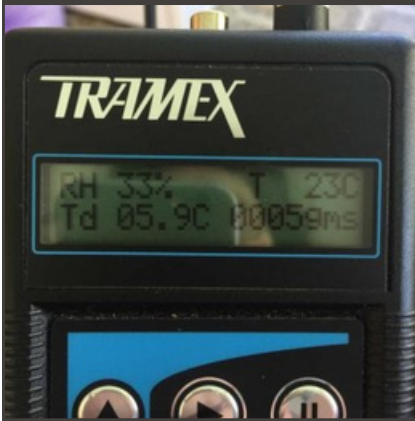
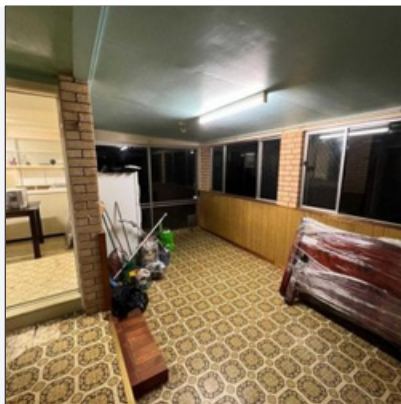
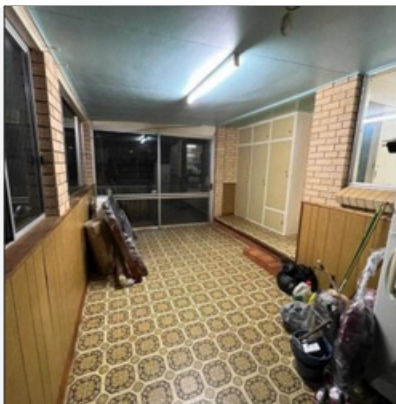
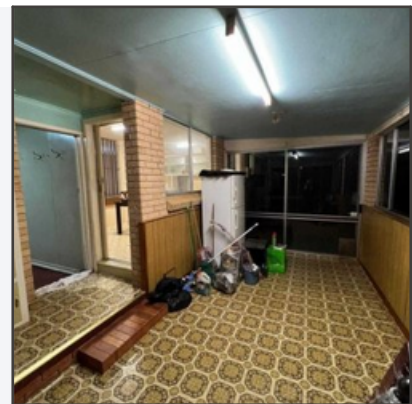
12/09/2024- Room Inspection Re-Attendance

Relative Humidity: – 33%

Room Temperature: – 05.9C
